Subsurface Investigation of

Petroleum Contamination at

Thompson's Garage

Woodstock, Vermont

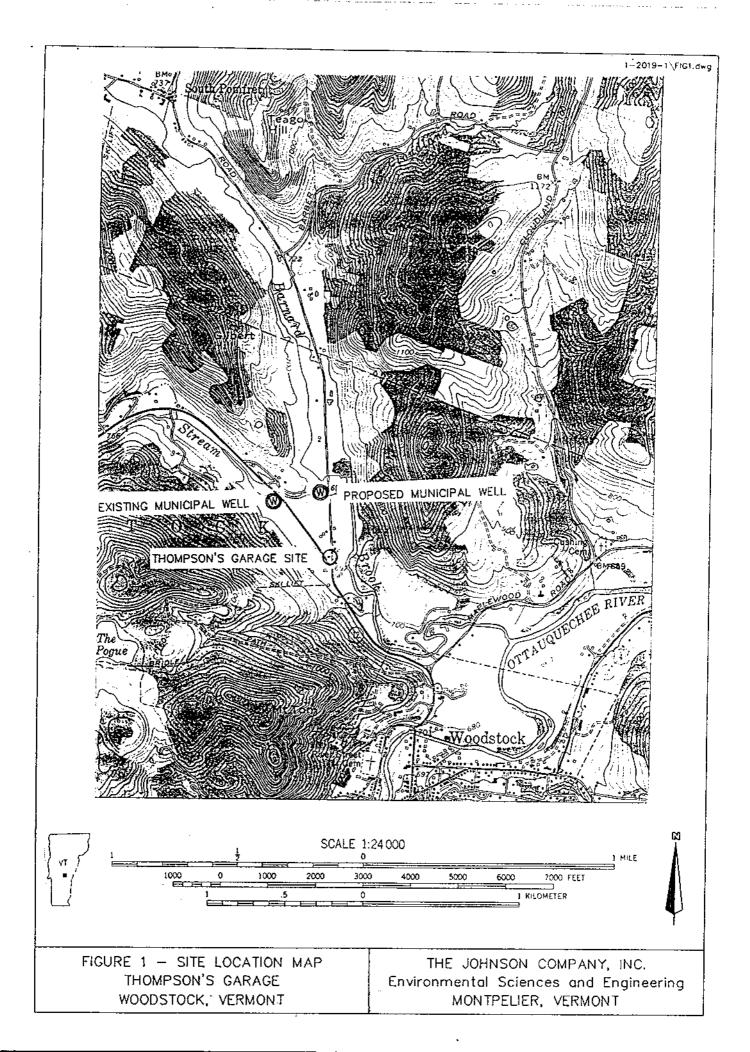
The Johnson Company, Inc., has completed a subsurface investigation of petroleum contamination at Thompson's Garage, Inc., in Woodstock, Vermont. Thompson's Garage is an auto maintenance and repair station and gasoline filling station on Vermont Route 12, in the Town of Woodstock, Vermont, at the junction of Rte. 12 and the North Pomfret Road (see Figure 1). The garage has existed at this location for many years.
